Objet : RE: GAN18505.1 - unusual PC-Test data

We seem to have a layout issue, with the placement of scribe line PCM structures in the Y08R reticle set. Y08R lots are failing all metal bridging & continuity tests, which are pad groups 18 & 19.

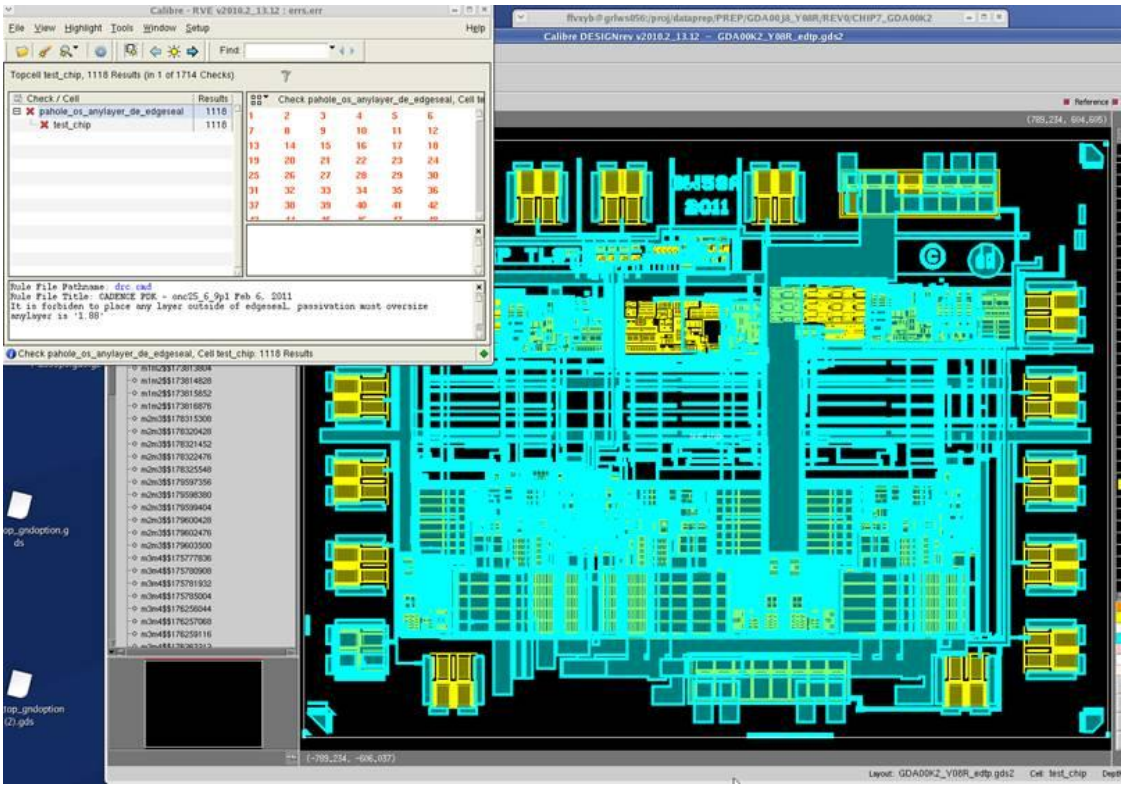
The DRC check below is intended to verify that ONC25 edgeseal exists, correct? If not, we need to create a check to verify that edgeseal is part of a product.

Can you explain the reasoning for using a non-standard edgeseal on NCP2815_Test chip 1 GDA00K2 Y08R? What was created is shorting the production PC-Test electrical monitors.

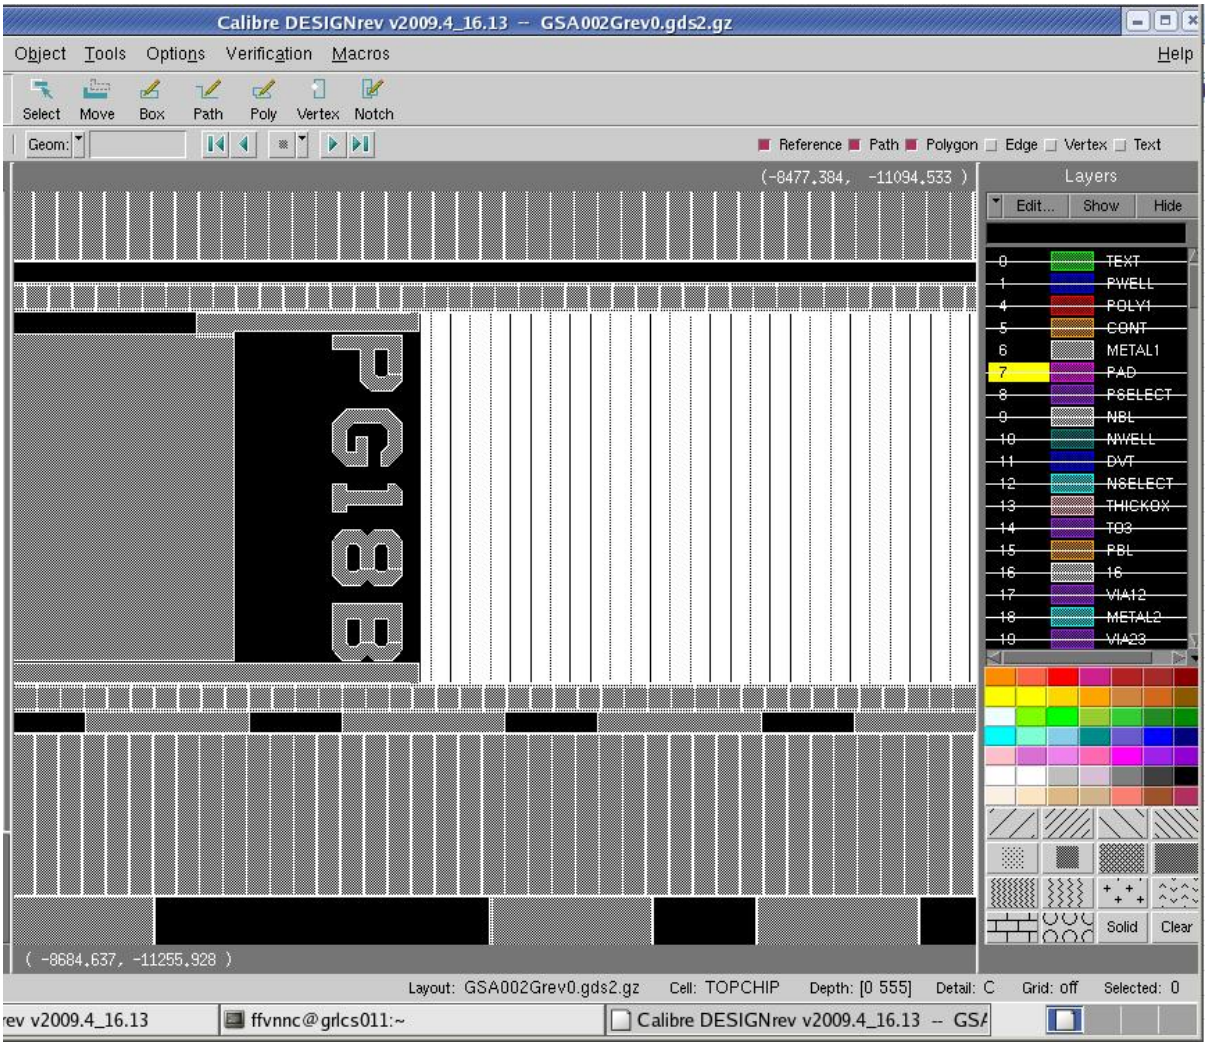
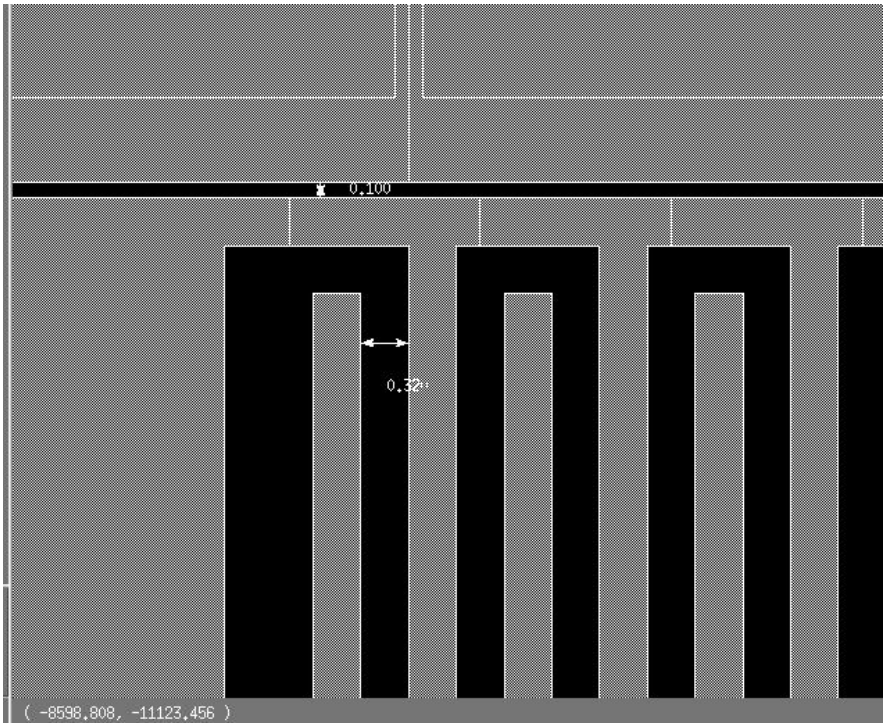
Reviewing the gds data shows sub-DR spacing alongside the m1comb (Metal 1 bridging) structure. The comb structure is fine (0.32um space) but alongside there is a 0.1um space.

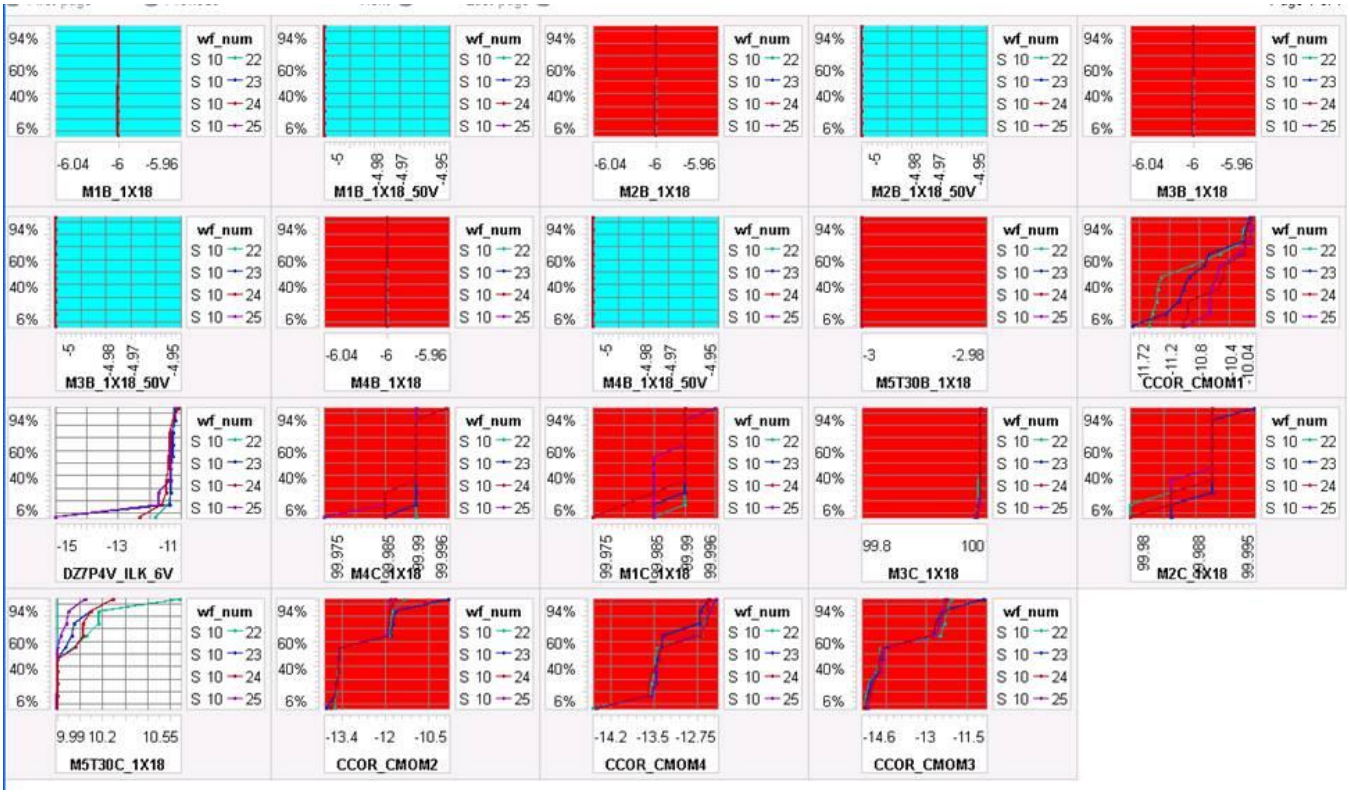
. We've not run this flavor of Y08R that I can see. The lot failed for M1C and M1B at Met1 and was sent on by Agajan.

This is both std and rework. The only parameter that didn't have more fails with the rework map was M5T30C.

Can you shine any light on these for me? If we truly were bridged, the FE would have the same catastrophic fails – and it doesn't.
